THE STREAMBANK EROSION CONTROL  
EVALUATION AND DEMONSTRATION ACT OF 1974  
SECTION 32, PUBLIC LAW 93-251

## Appendix C - Geotechnical Research

4. TITLE (and Subtitle) LITERATURE SURVEY AND PRELIMINARY EVALUATION OF STREAMBANK PROTECTION METHODS		5. TYPE OF REPORT & PERIOD COVERED Final report
7. AUTHOR(s) Malcolm P. Keown      Elba A. Dardeau, Jr. Noel R. Oswalt Edward B. Perry		6. PERFORMING ORG. REPORT NUMBER

Consisting of  
A SUMMARY REPORT OF LABORATORY RESEARCH AND FIELD  
EXPERIMENTS ON STREAM STABILITY AND IDENTIFICATION OF  
CAUSES OF STREAMBANK EROSION

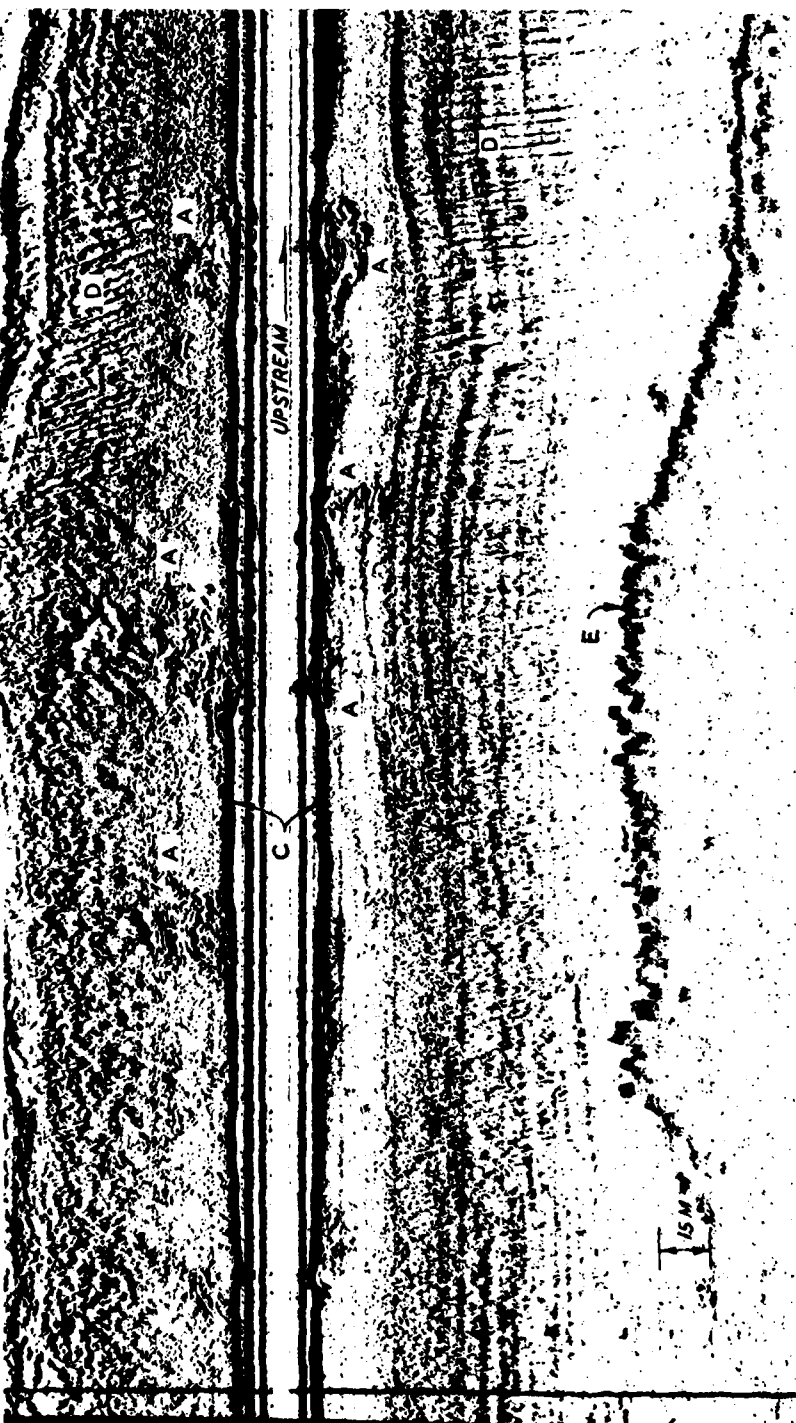
LARGE SUBAQUEOUS SLUMPS (A) EXTENDING FROM NEAR THE TOE OF THE RIGHT BANK (B) ARE THE MOST EVIDENT FEATURES ON THIS RECORD. THE SLUMP MATERIAL HAS ACCUMULATED AT THE BOTTOM OF THE BANK SLOPE WHERE IT DISPLAYS A HUMMOCKY PROFILE ALONG THE BOTTOM PROFILE (C). THE HERRINGBONE PATTERN (D) IS NOISE INTERFERENCE CAUSED BY A PASSING TOWBOAT. THE TOE OF THE LEFT BANK SLOPE IS AT (E). (HORIZONTAL SCALE 1 IN. = APPROXIMATELY 200 FT)

Figure C17. Side-scan sonar record of the Ohio River in vicinity of river mile 375 near Vanceburg, Kentucky

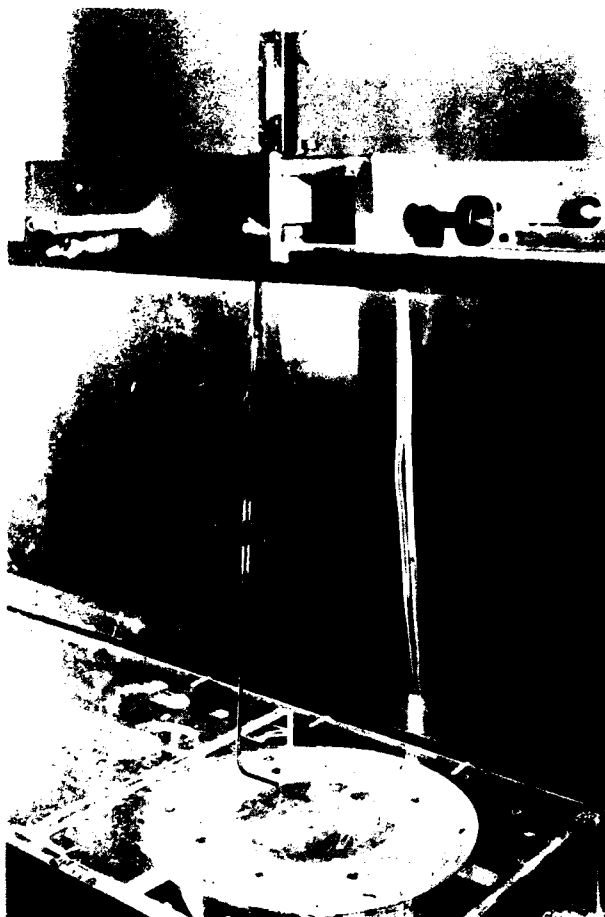
Figure C36. Pitot tube used to measure stagnation pressure and piezometric pressure in calibrating the flume
